Impediments to flow - Logjams

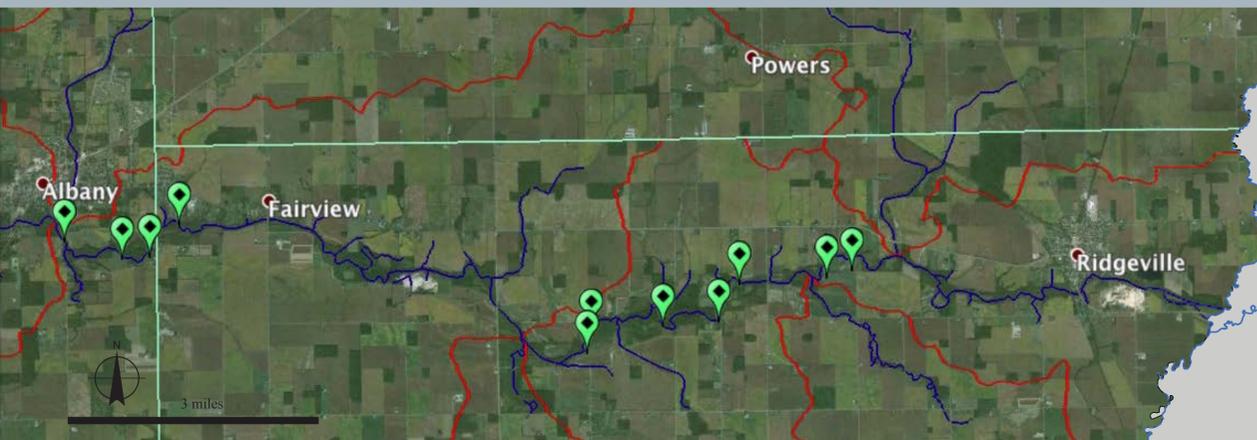
LOGJAM LOCATIONS

Students traveled to eleven logjam sites along the Mississinewa River between Albany and Ridgeville in October 2014. They collected multimedia at each site along with logjam dimensions, field chemistry, and water samples at locations upstream and downstream of the logjam.
